L. William Pearce
Site Vice President724-682-5234
Fax: 724-643-8069June 24, 2003
L-03-103U. S. Nuclear Regulatory Commission
Attention: Document Control Desk
Washington, DC 20555-0001**Subject: Beaver Valley Power Station, Unit No. 1
BV-1 Docket No. 50-334, License No. DPR-66
Reactor Head Inspection 60-Day Report**

Evaluation Report for 1R15
Visual and Under-head Inspection
of
Beaver Valley Unit 1
Reactor Vessel Head Penetrations
(Ref: Order EA-03-009)

June 2003

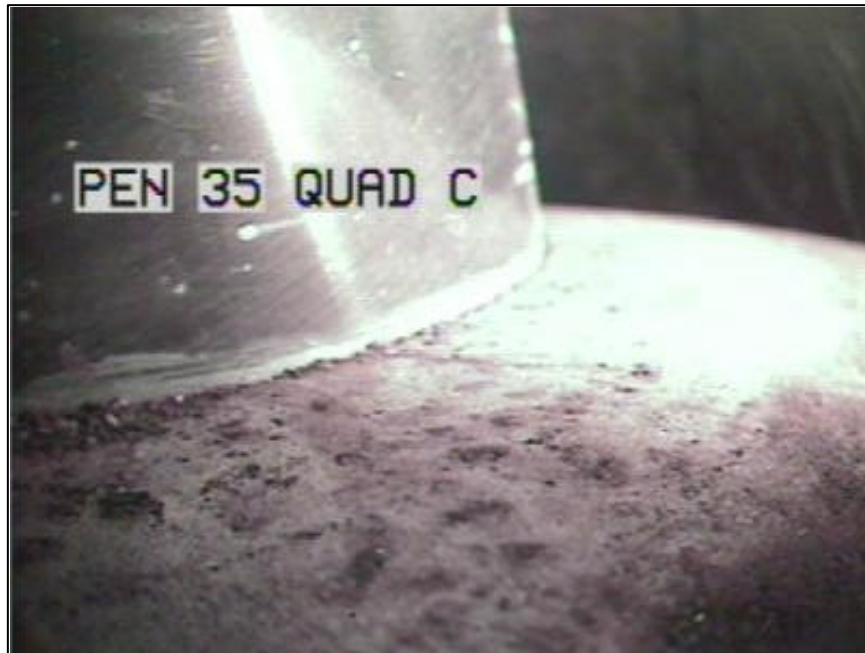
Figure 1: Typical 1R15 CRDM Penetration Condition

VT-2 visual inspection of 360° around each of the 65 CRDM penetrations and the vent line showed no indication of penetration leakage characteristic of a through-wall leak. Figure 1 shows the typical condition found around each penetration during the penetration exam.

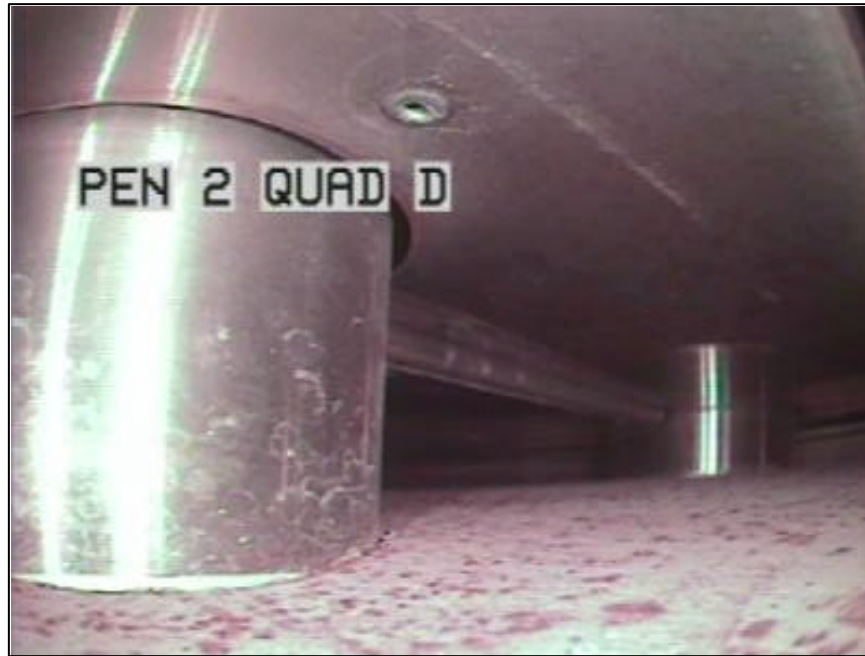
Figure 2: Typical 1R15 Carbon Steel Condition

The carbon steel assessment performed on 100% of the RPV head carbon steel base metal inside the ventilation shroud found no new degraded conditions on the RPV head surface. Figure 2 shows the typical condition of the RPV head base metal.

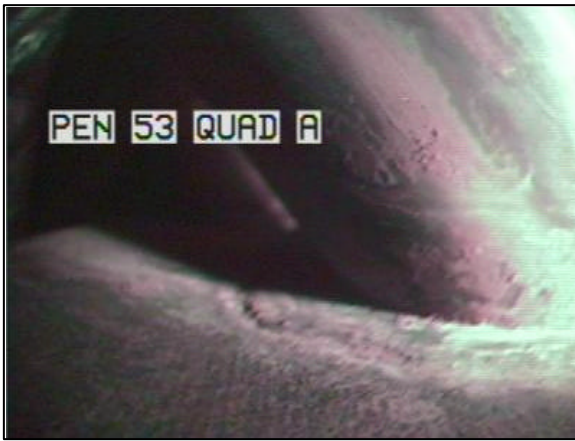
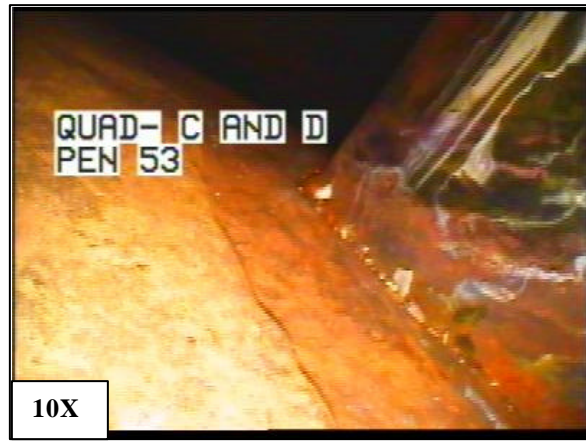
Figures 3 and 4: Penetration 53

Minor corrosion of the RPV head base metal was observed around CRDM Penetrations 53 and 65. This condition was previously observed in the visual inspection performed during the 1MO2 Maintenance Outage in November 2002 and in the 1R14 refueling outage in 2001 (Penetration #65). The leakage that caused the degradation was determined to have originated at the adjacent canopy seal (Penetration #53) above the RPV head mirror insulation. Following a warm water rinse of the RPV head in 1MO2, the extent of the degradation was assessed. This documentation was reviewed with the NRC BVPS site resident inspector in November.

The conditions of Penetrations 53 and 65 observed during the 1R15 refueling outage were compared with the previously documented conditions. No change in the condition of the RPV head base metal around Penetrations 53 and 65 was observed. Figures 3 through 6 show the conditions documented during 1R15.

The minor corrosion observed around Penetrations 53 and 65, previously evaluated during 1MO2 in November 2002 and reviewed with the NRC BVPS site resident inspector, was found to be approximately 1/8" in depth and 1/2" wide around the perimeter of the two CRDM penetrations. This degradation was concluded to be minor in nature and well within the acceptable limits for

the BVPS Unit 1 RPV Head. As no change in conditions was observed during 1R15, this assessment remains valid.

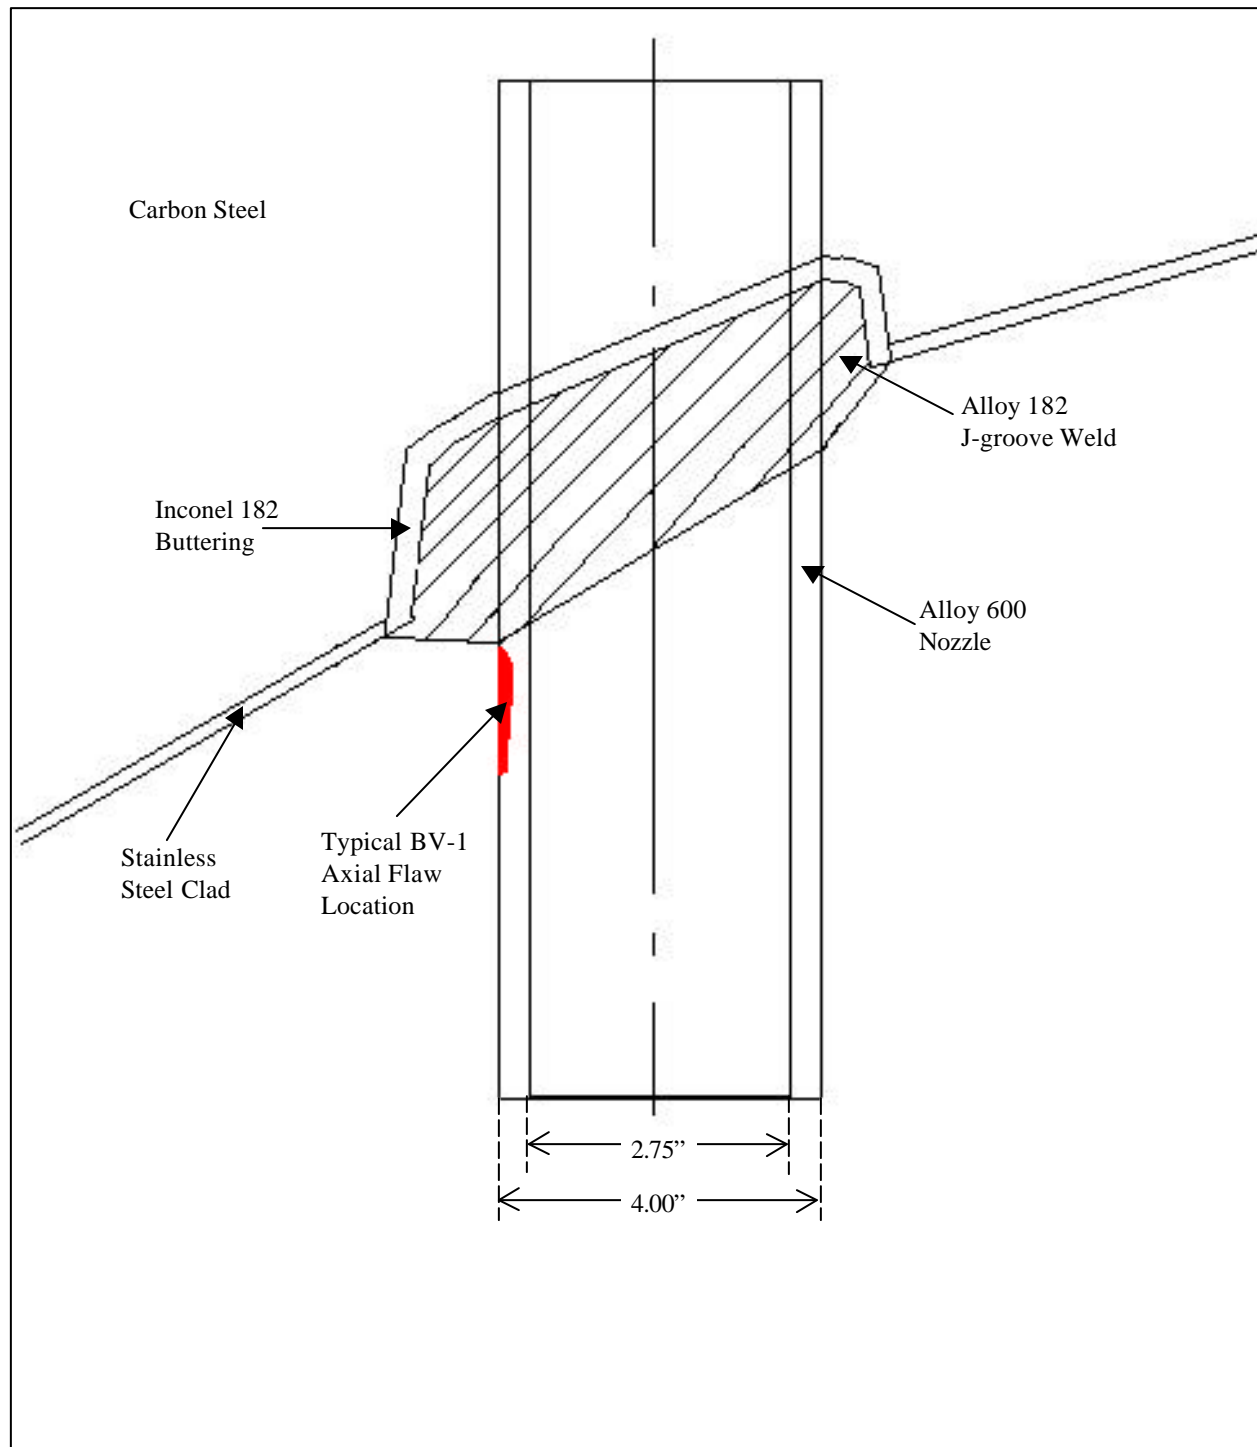
Figure 7: Typical Axial Flaw Location
Penetrations #50, 51, 52, and 53

Eddy current wetted surface examination was performed on the OD surface of all 65 CRDM penetrations. Reportable indications, with characteristics of Primary Water Stress Corrosion Cracking (PWSCC), were identified in the penetration tube scans of four CRDM locations. Penetrations #50, 51, 52, and 53 contained indications initially classified as having crack-like characteristics; single axial indications (SAI), single circumferential indications (SCI) and/or multiple circumferential indications (MCI). Following Time of Flight Diffraction (TOFD) Ultrasonic analysis of the four penetrations from the ID surface, all indications were ultimately

classified as axial in orientation. Neither eddy current nor ultrasonic test results identified any crack extension into the J-groove weld.

The details of the relevant indications found on Penetrations #50, 51, 52, and 53 are provided in the attached figures and tables. Figure 7 shows the typical location of each flaw axially on the penetration. Tables 1 through 4 describe the approximate length, depth, disposition, and circumferential location of each indication. Figures 8, 10, 12, and 14 show the tube profile and each indication extending up to the toe of the J-groove weld. Figures 9, 11, 13, and 15 show a top-view of each penetration and approximate location of the indications discovered.

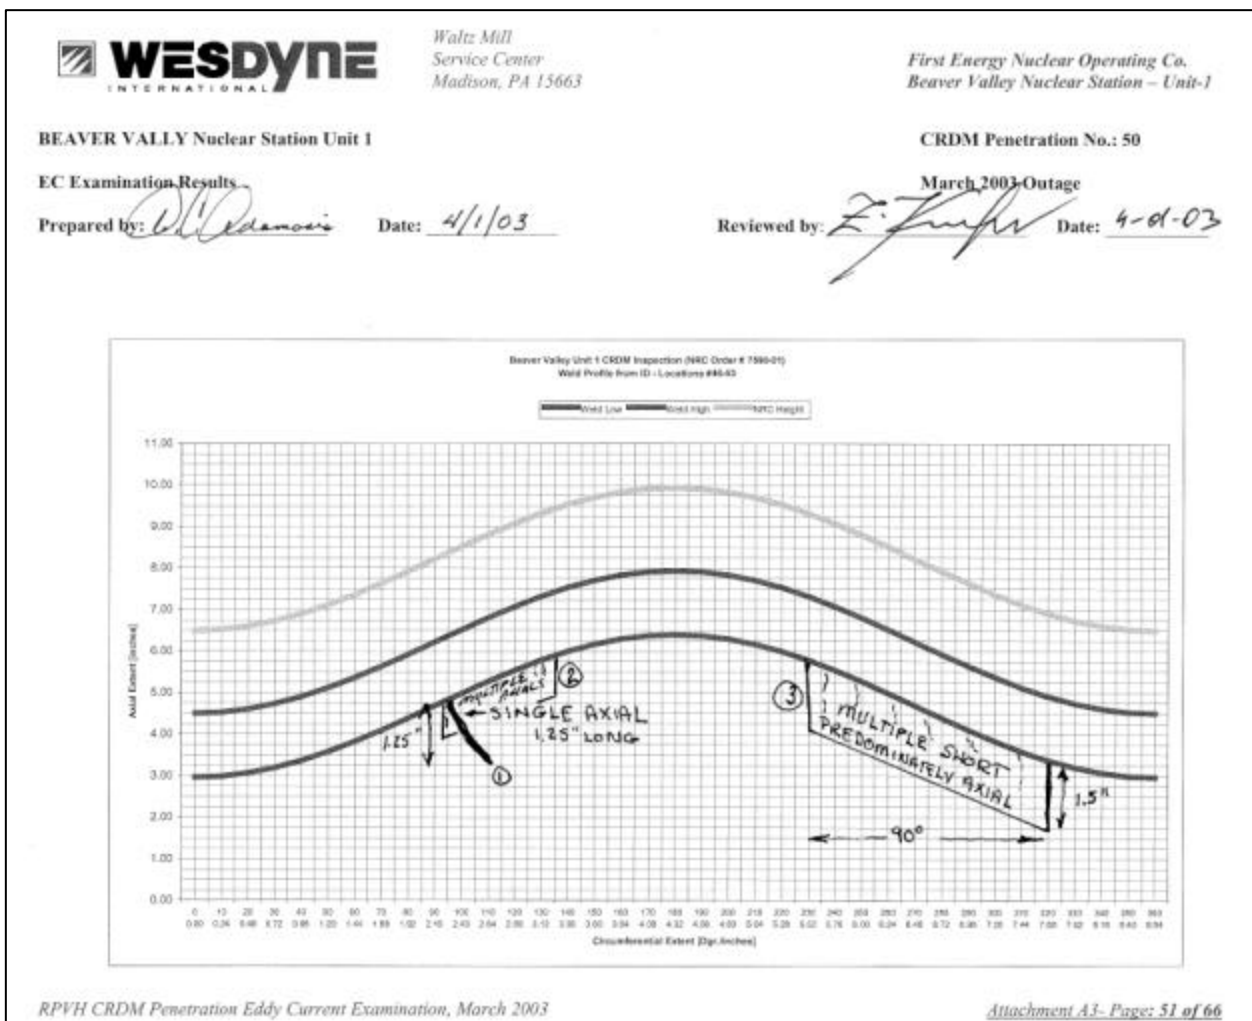
Figure 8: CRDM Penetration #50 Tube Profile

Table 1: Penetration #50 Flaw Characterization

#	Length (Inches)	Depth (Inches)	Disposition	Circ. Location
1	1.25"	0.30"	Single Axial	97°
2*	~0.8"	<0.125"	Multiple Shallow Axial	90°-135°
3*	1.55"-1.80"	<0.125"	Multiple Shallow Axial	230°-320°

*Length dimension indicates range of affected area not the length of individual flaws.

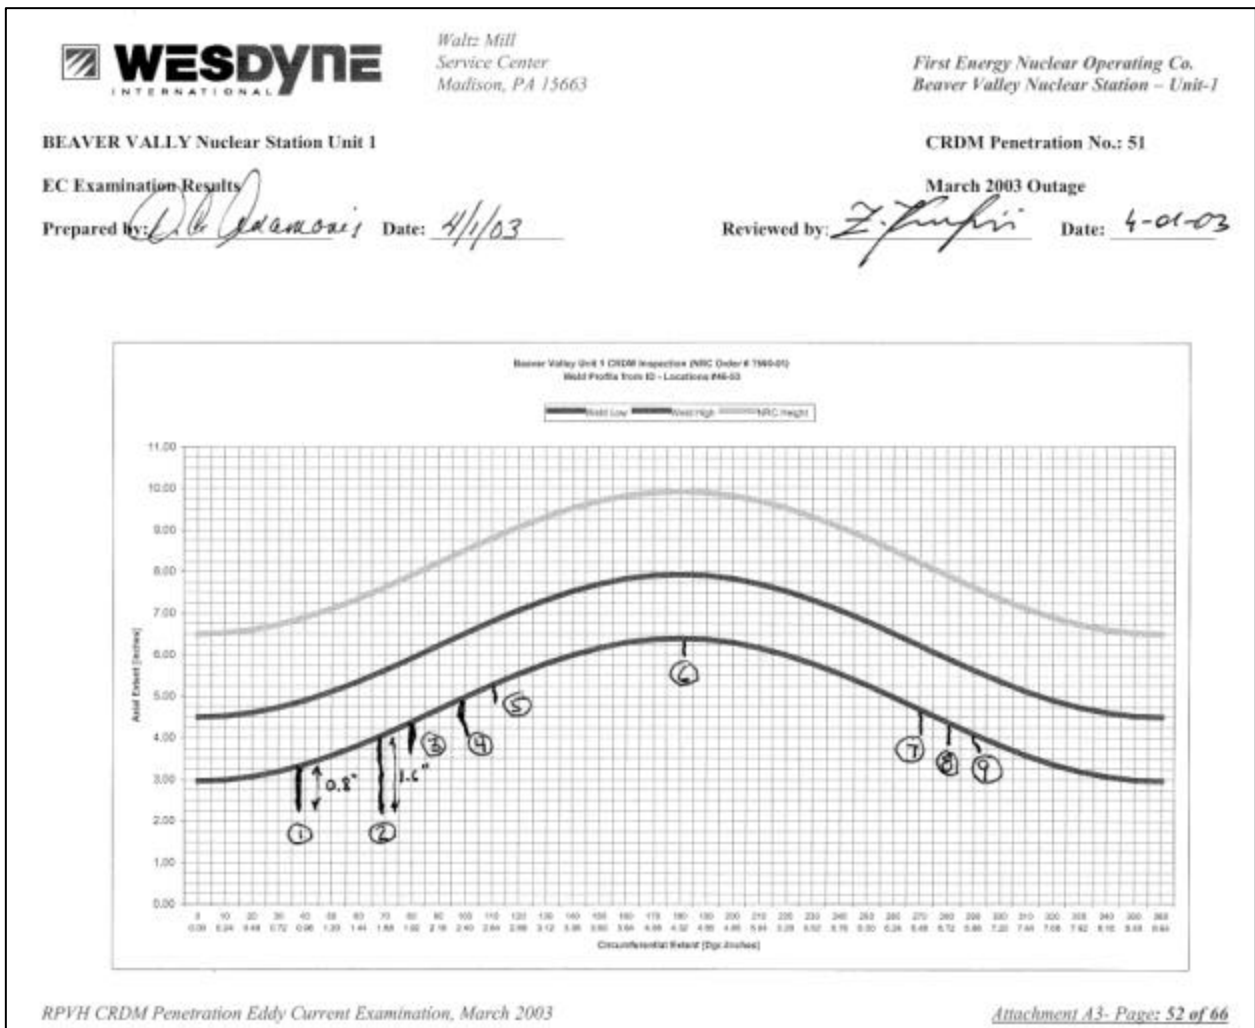
Figure 10: CRDM Penetration #51 Tube Profile

Table 2: Penetration #51 Flaw Characterization

#	Length (Inches)	Depth (Inches)	Disposition	Circ. Location
1	1.0"	0.25"	Single Axial	37°
2	1.6"	0.25"	Single Axial	67°
3	0.6"	0.25"	Single Axial	80°
4	0.8"	0.25"	Single Axial	90°
5	0.85"	0.25"	Single Axial	110°
6	0.35"	0.25"	Single Axial	182°
7	0.25"	0.25"	Single Axial	270°
8	0.3"	0.20"	Single Axial	280°
9	0.3"	0.20"	Single Axial	290°

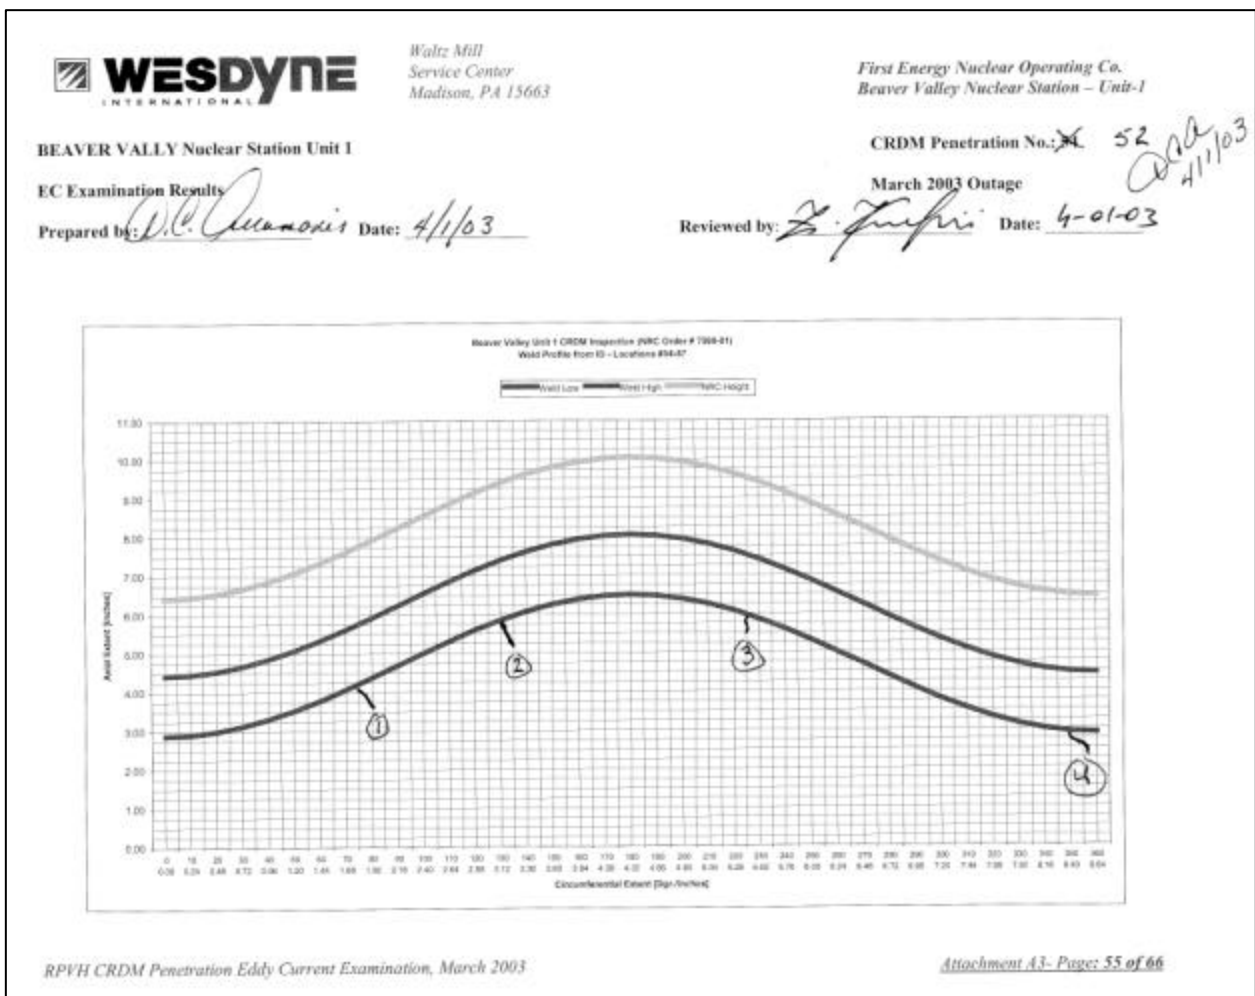
Figure 12: CRDM Penetration #52 Tube Profile

Table 3: Penetration #52 Flaw Characterization

#	Length (Inches)	Depth (Inches)	Disposition	Circ. Location
1	0.3"	0.25"	Single Axial	75°
2	0.3"	0.20"	Single Axial	130°
3	0.3"	0.25"	Single Axial	225°
4	0.3"	0.20"	Single Axial	350°

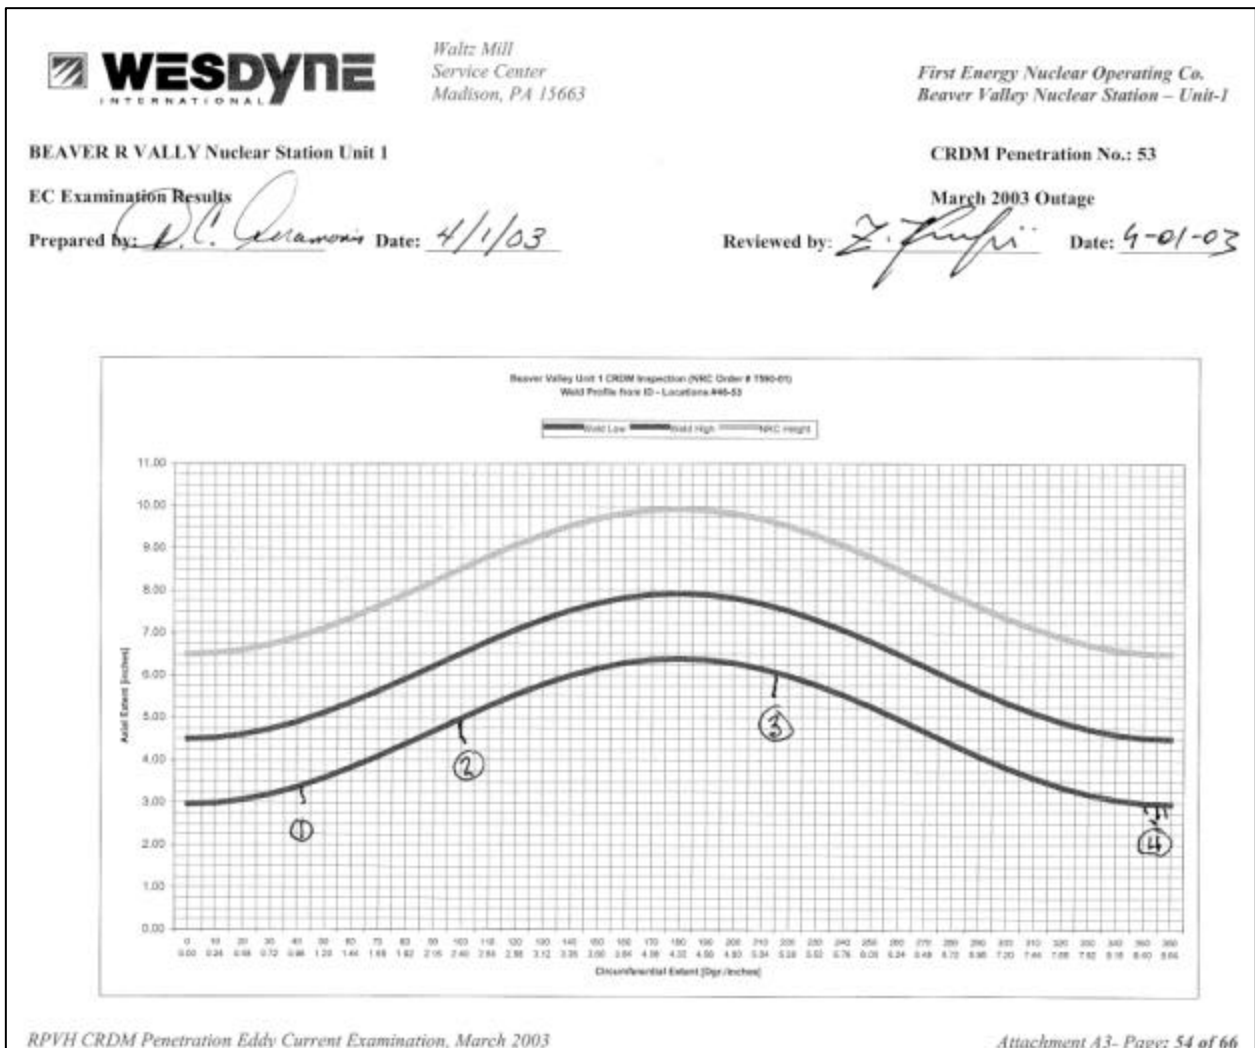
Figure 14: CRDM Penetration #53 Tube Profile

Table 4: Penetration #53 Flaw Characterization

#	Length (Inches)	Depth (Inches)	Disposition	Circ. Location
1	0.3"	0.25"	Single Axial	42°
2	0.3"	0.20"	Single Axial	100°
3	0.3"	0.25"	Single Axial	215°
4	0.4"	0.15"	Multiple Shallow Axial	355°
